[Docket No. FAA-2012-0630; Directorate Identifier 2011-SW-010-AD]

Airworthiness Directives; Eurocopter France Helicopters

ACTION: Notice of proposed rulemaking (NPRM).

SUMMARY: We propose to adopt a new airworthiness directive (AD) for Eurocopter France EC130B4 helicopters. This proposed AD is prompted by an in-flight cracking and failure of a center windscreen. The proposed actions are intended to detect a crack in the blending radii of the center windscreen to prevent failure of the windscreen, injury to the flight crew, and subsequent loss of control of the helicopter.

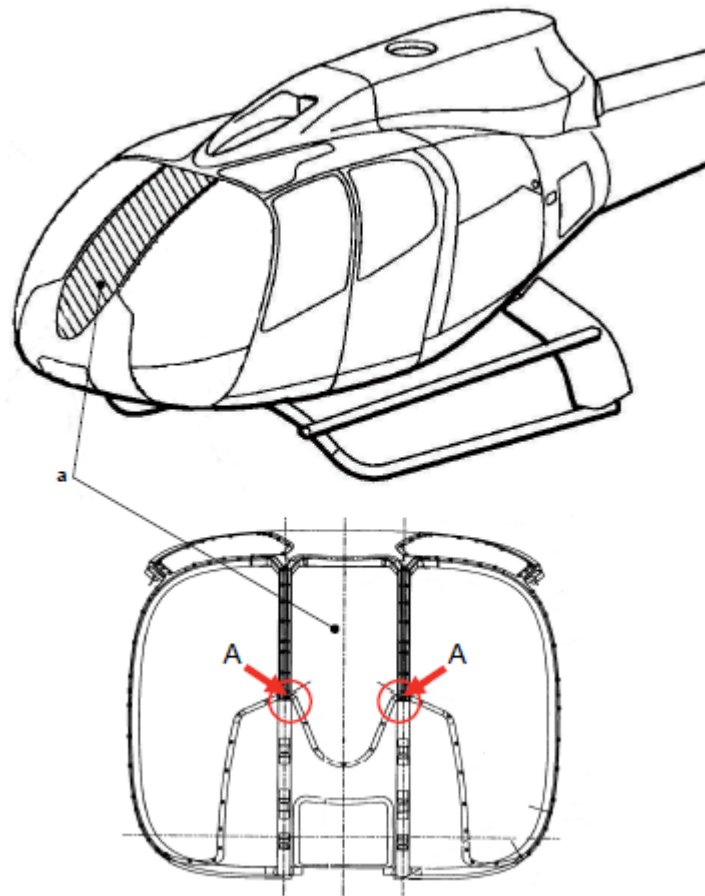
This AD defines the unsafe condition as a crack in the blending radii of the center windscreen, which could lead to failure of the center windscreen, injury to the flight crew, and subsequent loss of control of the helicopter.

(1) Until the center windscreen is replaced with center windscreen P/N 350A25-9045-20, before each flight, visually check the center windscreen for a crack in the area of the blending radii where the front-lower part of the center windscreen joins the front fuselage as depicted in Figure 1 of this AD. This visual check may be performed by the owner/operator (pilot) holding at least a private pilot certificate, and must be entered into the aircraft records showing compliance with the AD in accordance with Title 14 Code of Federal Regulations (14 CFR) §§ 43.9 (a)(1)-(4) and 14 CFR § 91.417(a)(2)(v). The record must be maintained as required by 14 CFR §§ 91.417, 121.380, or 135.439.

(2) If there is a crack or if a pilot indicates that the center windscreen distorted during flight, before further flight, replace the center windscreen with an airworthy center windscreen, P/N 350A25-9045-20, in accordance with the Accomplishment Instructions, paragraphs 2.B.2.b. through 2.B.2.b.4. of Eurocopter Service Bulletin No. 56-003, Revision 0, dated November 16, 2010.

(3) Within 12 months, replace the center windscreen with an airworthy center windscreen, P/N 350A25-9045-20, in accordance with the instructions contained in paragraph (d)(2) of this AD.

(4) Replacing the center windscreen with center windscreen, P/N 350A25-9045-20, constitutes terminating action for the requirements of this AD.
